## CIVIL AERONAUTICS BOARD

**ACCIDENT INVESTIGATION REPORT**

**NORTHWEST AIRLINES, INC.—WINONA, MINNESOTA—AUGUST 29, 1948****The Accident**

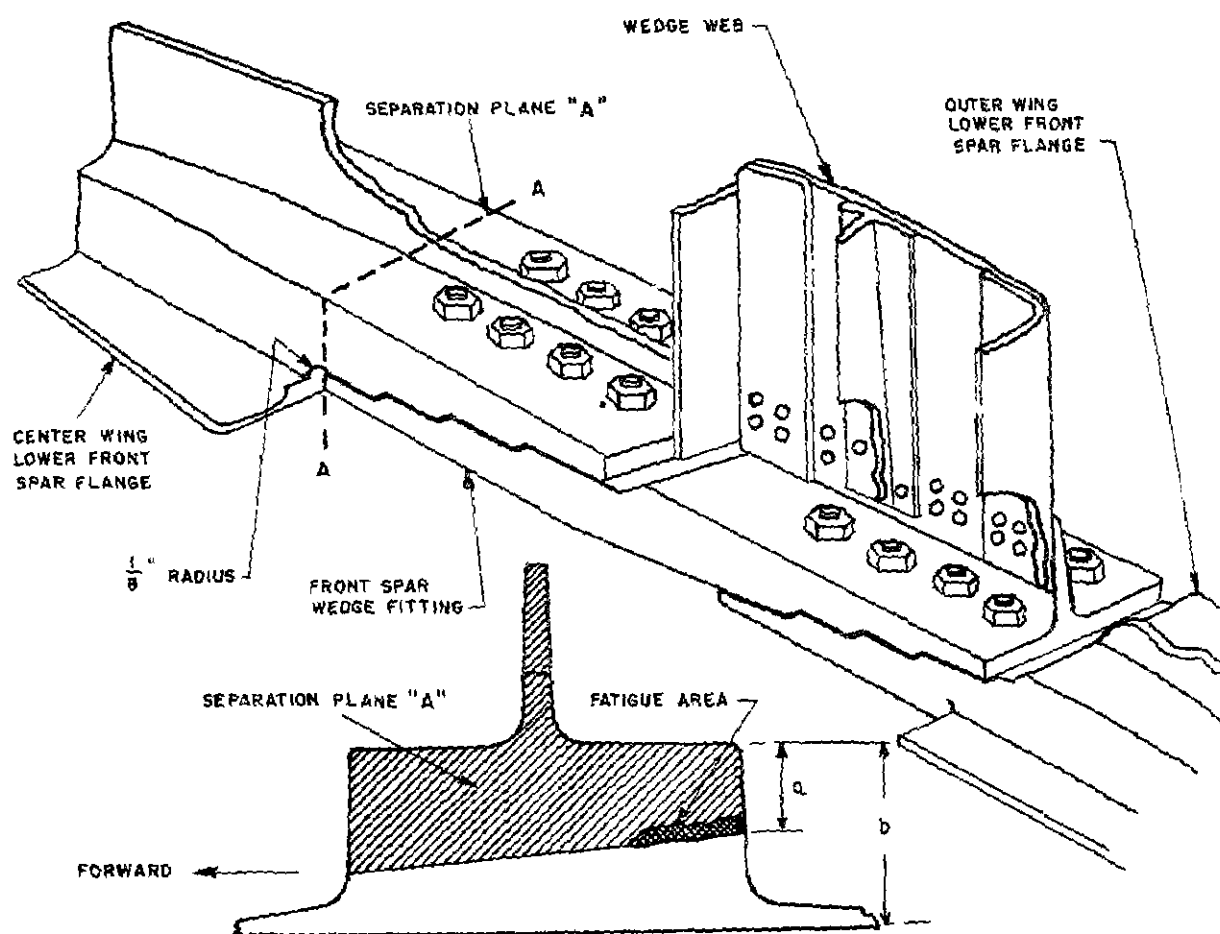
## WING ROOT FITTING

The outer wing front and rear lower spar flanges attach to the center wing front and rear lower spar flanges by means of a dihedral wedge as illustrated in the attached drawing. Originally, the spar flanges were bolted directly together, but tests of the prototype airplane demonstrated a need for a greater lateral stability. Therefore, the outer wing was rotated seven degrees upward by means of incorporating the dihedral wedge in the attachment of the outer wing to the center section. It will be noted in the drawing of this part that the attachment ends of the lower spar flanges and dihedral wedge have four steps or vertical increases in thickness. In each step the vertical increase in thickness is approximately 13/64 of an inch, except for the fourth step inboard on the center section spar flange where the vertical increase in the thickness is approximately 3/4 of an inch. The radius in the fillet of these steps is approximately 1/8 of an inch.

Evidence indicated that the outer wing had first separated from the center section in the fillet of the fourth step of the lower front center section spar flange. Examination of this fracture revealed that the separation had started from a fatigue crack approximately 7/8 of an inch long, and 3/32 of an inch deep, the remaining cross section of the material at this point failing from tension.

The particular design of the connection of the lower flange for the front spar of the outer panel to the center panel for the Martin 202 is conducive to high local stress concentration. Hence, it is readily susceptible to fatigue. These high local stress concentrations are due to the following characteristics: the fitting contained fillets of a small radius in the step down of 1/8 inch, there was a large sudden change in cross section in the fourth step down inboard from the attachment, increasing the depth to approximately twice its thickness, and the cross sectional area was designed to a high percentage of the ultimate strength of the material.

6. The fillet of the fourth step inboard of the lower left front center section spar flange revealed a fatigue fracture approximately 7/8 of an inch long and 3/32 of an inch deep. The remaining area failed in tension.

SCHEMATIC SECTION OF SEPARATION OF LOWER FLANGE SHOWING FATIGUE AREA AND ALSO  
SUDDEN INCREASE OF DEPTH OF FLANGE "a" TO APPROXIMATELY TWICE THE DEPTH AS INDICATED BY "b"

At the present time the wing root fittings on the Martin 202s are being given frequent and thorough inspections for the development of fatigue cracks, and the operating speeds have been reduced ten percent. In addition, the front center section spar flange has been modified so as to include five steps or vertical increases in thickness to avoid any radical change in cross section. The radius in the fifth step fillet has been increased from 1/8 of an inch to 3/4 of an inch; two bolts have been added, and all parts have been polished. In general the above constitutes present corrective action approved by the Administrator of Civil Aeronautics. It is considered to be temporary in nature, but sufficient for safe operation until 3,000 hours of flight. After 3,000 hours of flight have been accumulated on the aircraft or before, the airplane will be modified at the Martin Company with a permanent correction which involves extensive structural changes to the wing.
